Hill's Property Inspection LLC

Property Inspection Report

123 Anywhere Street, Somewhere, Oregon 12345
Inspection prepared for: John Doe
Date of Inspection: 10/13/2019 Time: 9:00
Age of Home: 39 Size: 2200
Weather: Sunny

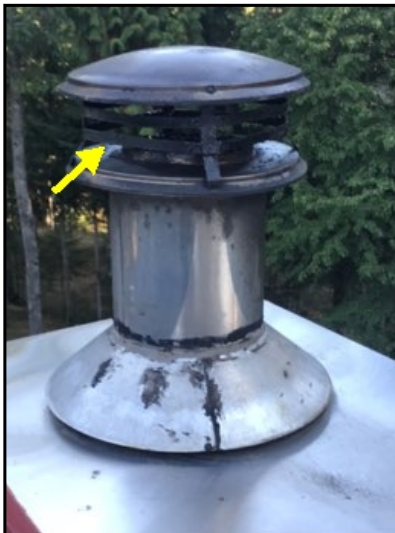
- **SAFETY CONCERNS:** Chimney rain cap appears to be deteriorated and creosote has built up. Recommend hiring a licensed chimney installer to evaluate and repair or replace. See picture.

Accumulated creosote noted.

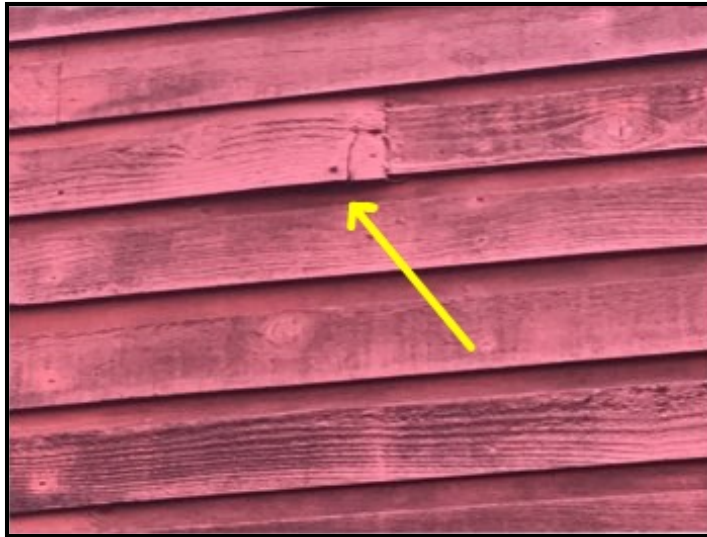
- Some areas need restaining, priming and/or repainting.
- Some siding on the west side is buckling. Moisture can possibly intrude into interior causing further damage to the structure. Recommend hiring a licensed siding contractor to evaluate. See picture.

Location: Near kitchen window. Buckling siding noted.

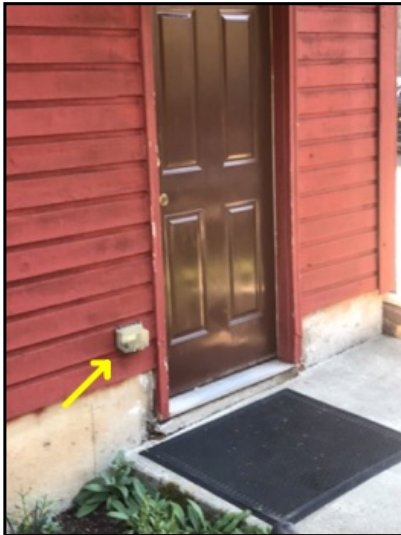
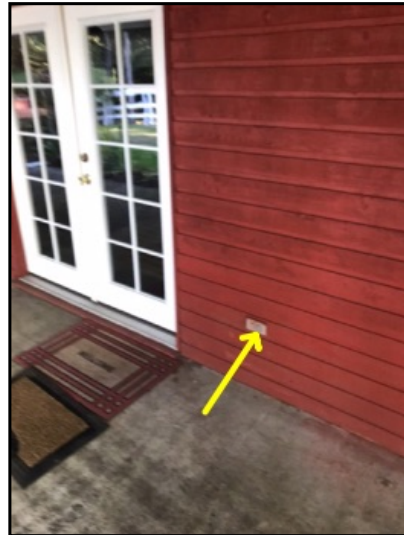
- **SAFETY CONCERN:** No **GFCI** protection present on any outdoor receptacles. Recommend hiring a licensed electrician to install GFCI protected receptacles to help prevent a shock/electrocution hazard. See picture.

Not GFCI protected.

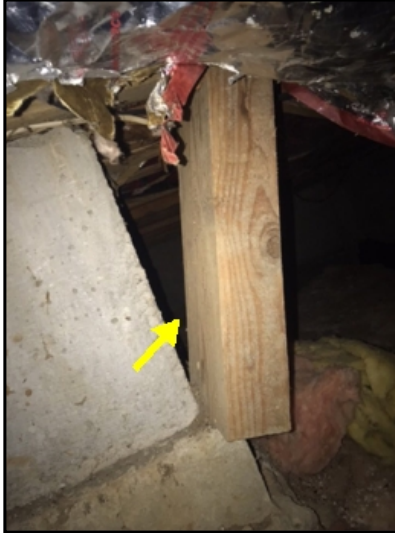
- One of the post appears to lack fasteners to prevent possible kick-out of pier at bottom. Recommend hiring a licensed contractor to evaluate the pier. See picture.

Pier not secured noted.

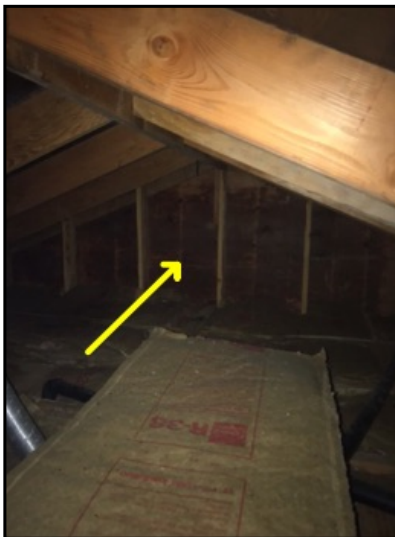
- Appears to be moisture in the attic. Recommend hiring a licensed ventilation contractor to evaluate.

Possible moisture noted.

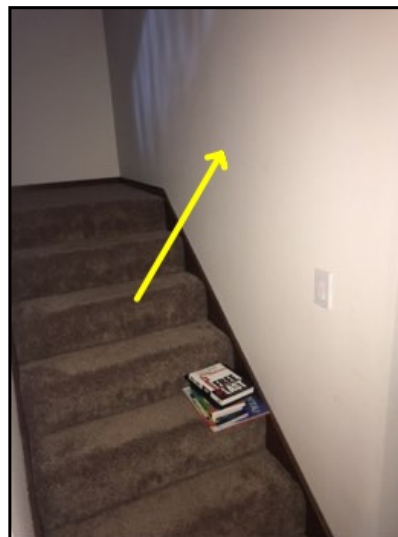
• **Safety Issue: A handrail is missing. Recommend hiring a licensed contractor to install handrail for safety. See picture,**

Missing handrail noted.

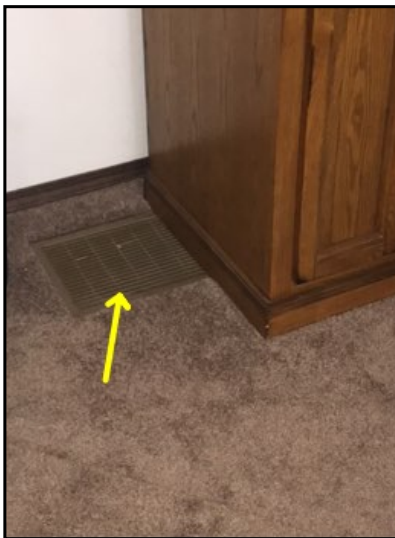
- Location: Back corner of room. Recommend raising any furniture over floor returns or register for good airflow.

Restricted airflow noted.

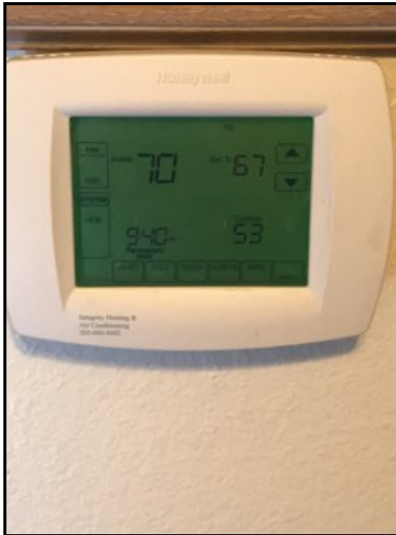
Thermostat

- Location: Hallway.
- Functional at the time of inspection.
- Digital - programmable type.
- Thermostats are not checked for calibration or timed functions.
